# Manhole Inspection Summary

Manhole # S37S\_\_009MH

Insp Date: **2/21/08 8:35 AM**

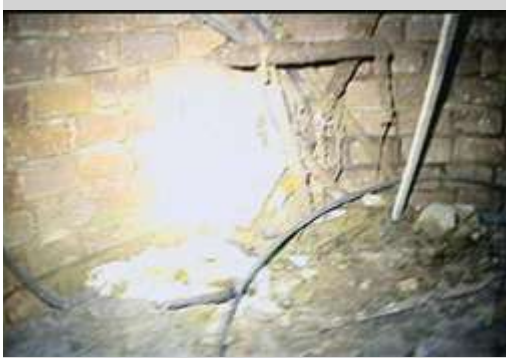
Misc.

Condition: ☒ Sound ☐ Cracked ☐ Root Intrusion ☐ Deteriorated ☐ Leaks ☐ Debris

bench debris

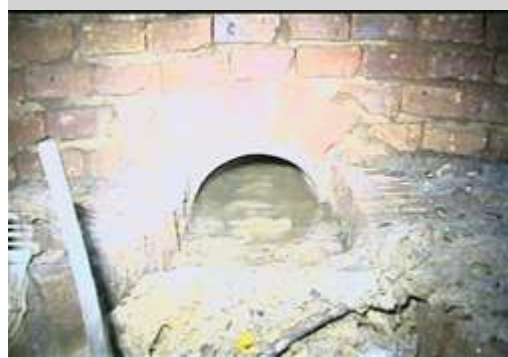
Defect 3

Condition: ☐ Sound ☐ Cracked ☐ Root Intrusion ☐ Deteriorated ☐ Leaks ☒ **Debris**

channel cond debris

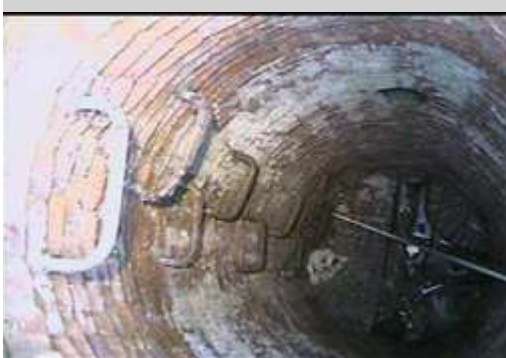
Defect 2

**Steps** Count: **8** Missing: **0** ☒ **Corroded**

corroded steps

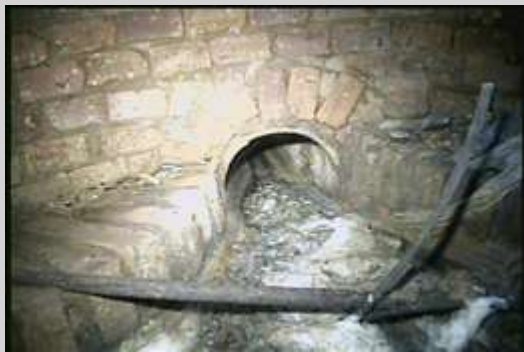
12 O'Clock Outflow

Deposits: ☐ None ☐ Mud ☒ **Sludge** ☐ Debris ☐ Grease

Silt Depth: **1** (in.) Deposits Extent: **Light**

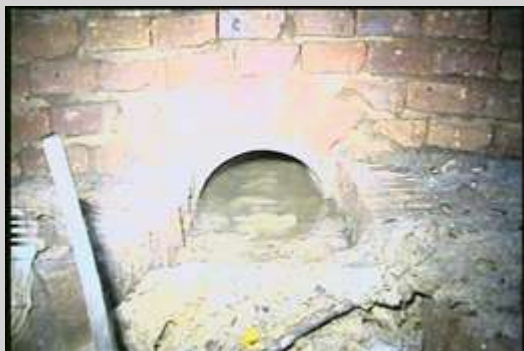
3 O'Clock Inflow

Deposits: ☐ None ☐ Mud ☒ **Sludge** ☐ Debris ☒ **Grease**

Silt Depth: **4** (in.) Deposits Extent: **Medium**

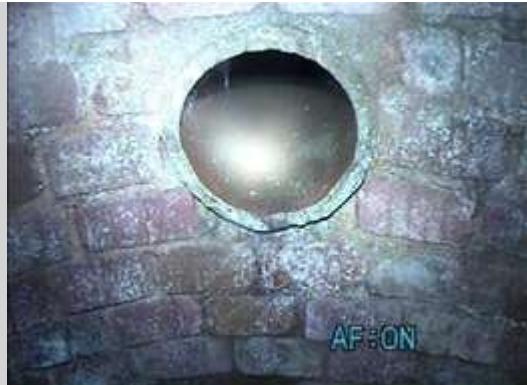
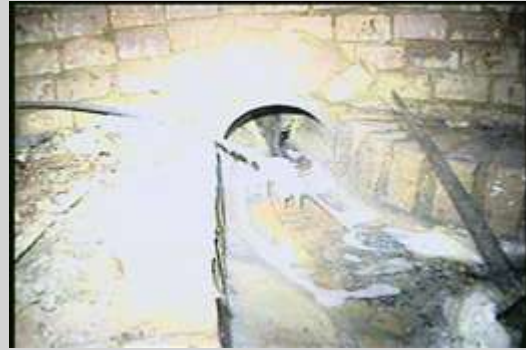
9 O'Clock Inflow

Deposits: ☐ None ☐ Mud ☒ **Sludge** ☐ Debris ☐ Grease

Silt Depth: **4** (in.) Deposits Extent: **Heavy**

Drop: **Outside**
